SECTION 18

STRUCTURAL REPAIR

18-1. STRUCTURAL REPAIR.

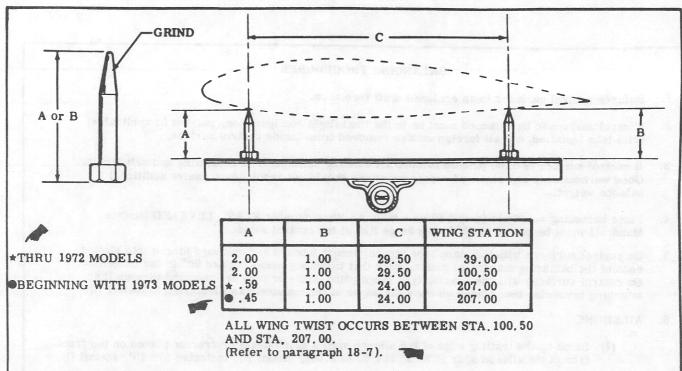
MEASURING WING TWIST

If damage has occurred to a wing, it is advisable to check the twist. The following method can be used with a minimum of equipment, which includes a straightedge (32" minimum length of angle, or equivalent), three modified bolts for a specific wing, and a protractor head with level.

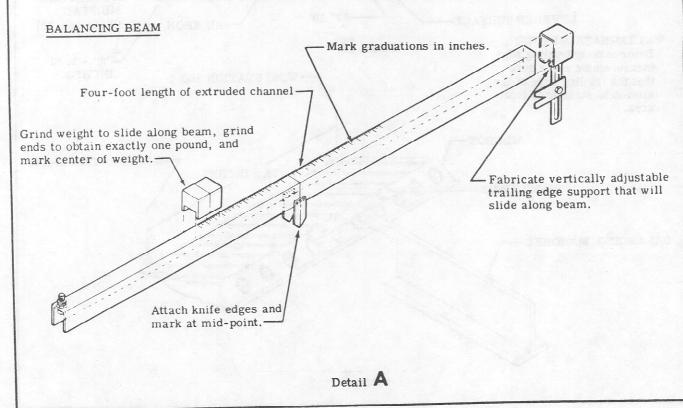
Figure 18-3. Control Surface Balancing (Sheet 2 of 5)

- f. If the rudder/elevator is correctly balanced, the position of the sliding weight with respect to the rudder/elevator hinge line, will produce a moment about the hinge line somewhere within the underbalance tolerance listed in the chart on (Sheet 5 of 5).

- g. If modification of the rudder/elevator balance weight is necessary to correct an out-of-balance condition, the balance weight can be lightened by drilling out part of the weight. The weight can be increased by fusing bar stock solder to the weight after removal from rudder/elevator.

18-36. AILERON BALANCING. Following repair, replacement or painting, the aileron must be balanced. Complete instructions for fabricating balancing fixtures and mandrels and their use are given in figure 18-3.

18-49. ELEVATOR AND RUDDER BALANCING. Following repair, replacement or painting, the elevators and rudder must be balanced. Complete instructions for fabricating balancing fixtures and mandrels and their use are given in figure 18-3.

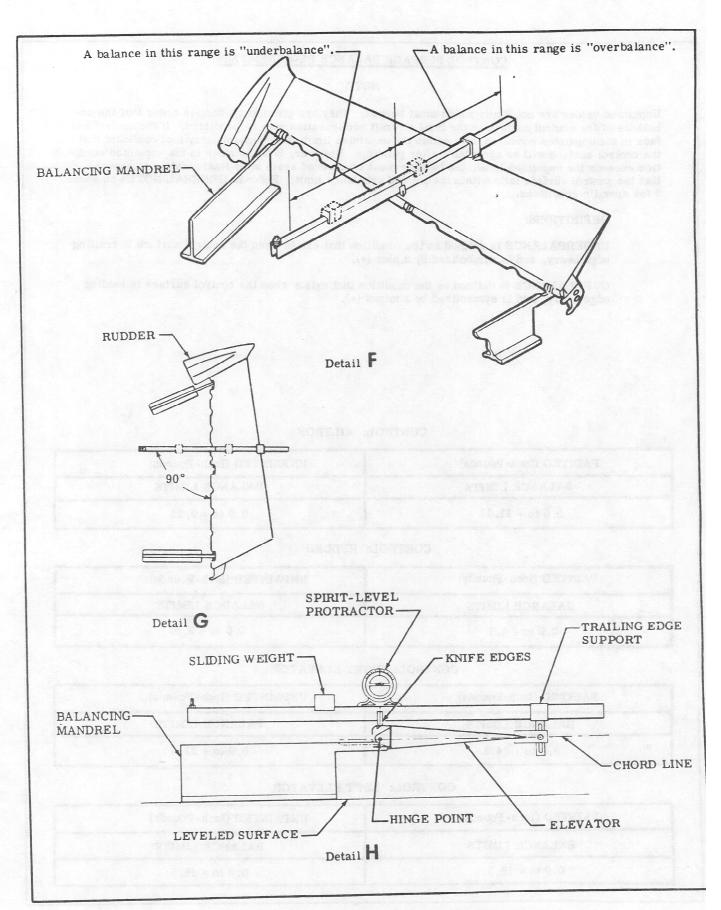
Figure 18-3. Control Surface Balancing (Sheet 4 of 5)

CONTROL SURFACE BALANCE REQUIREMENTS

UNDERBALANCE is defined as the condition that exists when the control surface is trailing edge heavy, and is symbolized by a plus (+).

CONTROL: LEFT ELEVATOR

PAINTED (Inch-Pounds)	UNPAINTED (Inch-Pounds)		
BALANCE LIMITS	BALANCE LIMITS		
0.0 to + 18.5	0.0 to + 15.5

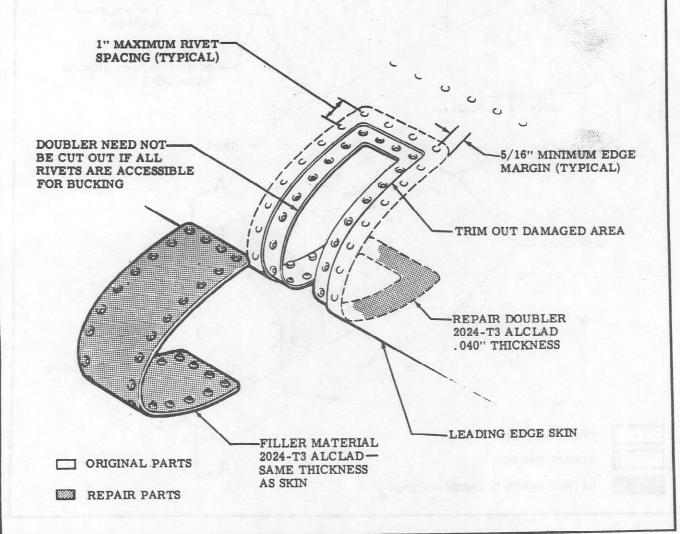
- 1. Dimple leading edge skin and filler material; countersink the doubler.
- 2. Use MS20426AD4 rivets to install doubler.
- Use MS20426AD4 rivets to install filler, except where bucking is impossible. Use CR162-4 Cherry (blind) rivets where regular rivets cannot be bucked.
- 4. Contour must be maintained; after repair has been completed, use epoxy filler as necessary and sand smooth before painting.
- 5. Vertical size is limited by ability to install doubler clear of front spar.
- 6. Lateral size is limited to seven inches across trimmed out area.
- 7. Number of repairs is limited to one in each bay.

18-34. REPAIRABLE DAMAGE. The repair shown in figure 18-9 may be used to repair damage to aileron leading edge skins. Figure 18-4 may be used to repair damage to flat surfaces between corrugations, when damage area includes corrugations refer to figure 18-3A. It is recommended that material used for repair be cut from spare parts of the same guage and corrugation spacing. Following repair the aileron must be balanced. Refer to paragraph 18-36 and figure 18-3 for balancing the aileron. If damage would require a repair which could not be made between adjacent ribs, see the following paragraph.

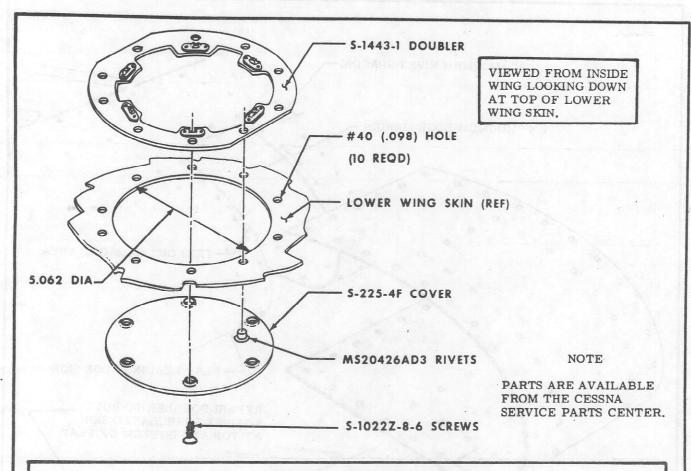
PRECAUTIONS

- 1. Add the minimum number of access holes necessary.
- 2. Any circular or rectangular access hole which is used with approved optional equipment installations may be added in lieu of the access hole illustrated.

- b. Determine position of doubler on wing skin and center over centerlines. Mark the ten rivet hole locations and drill to size shown.
 - c. Cutout access hole, using dimension shown.

- d. Flex doubler and insert through access hole, and rivet in place.
 - e. Position cover and secure, using screws as shown.
